30th May 2019

Turkey Oak – The Green, Main Street, Old Dalby

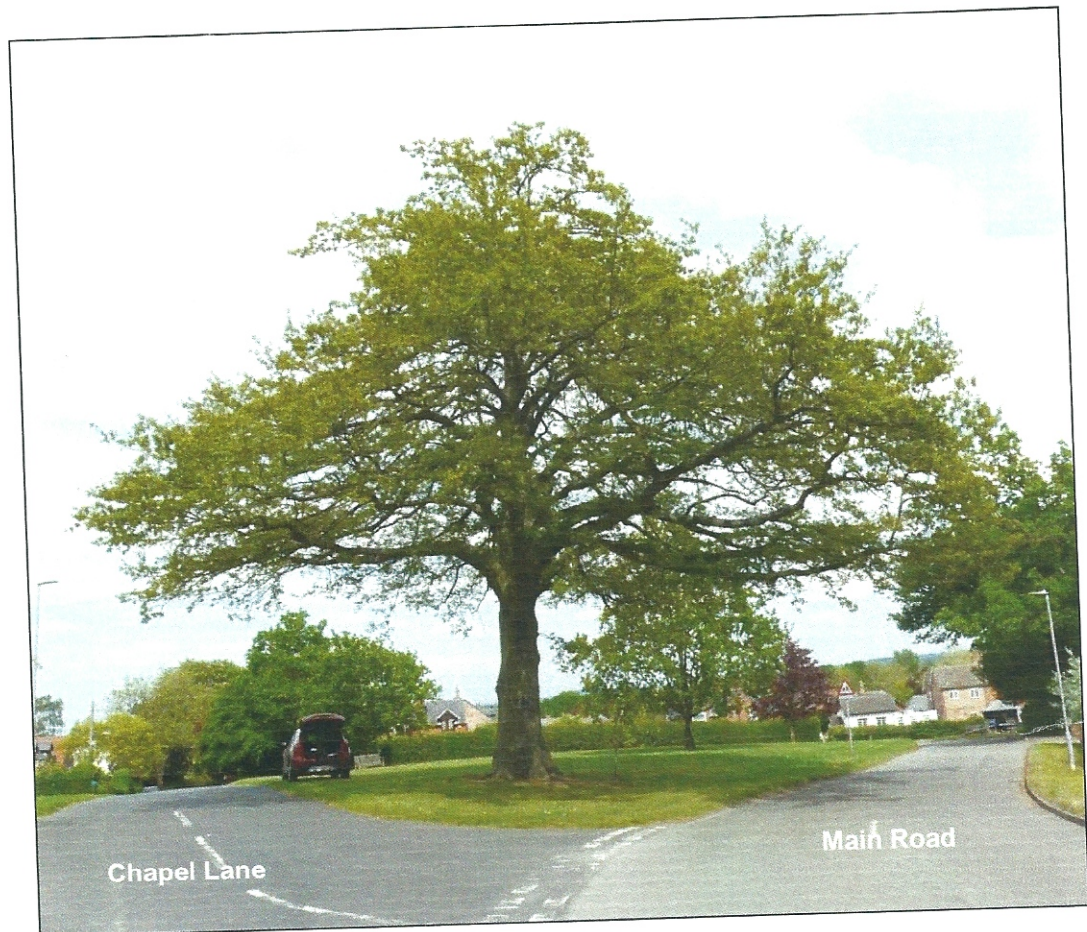
Photograph 1: Turkey oak tree viewed from the south-east

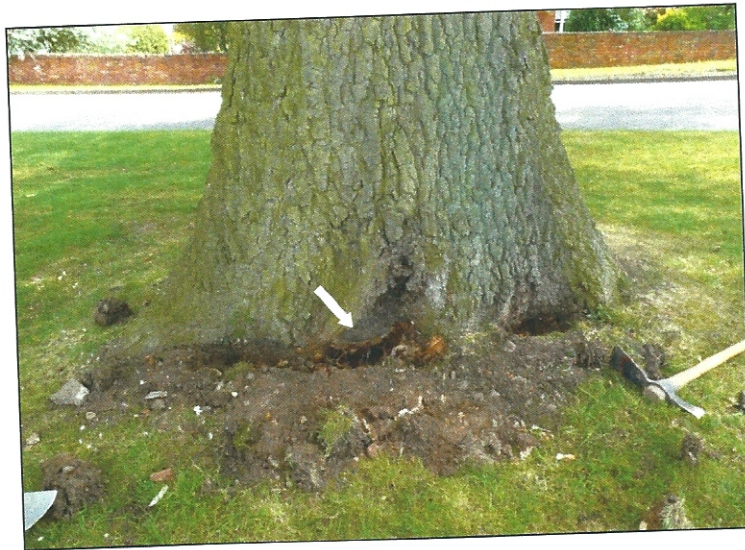
The lower section of the trunk is heavily swollen and clearly extensively decayed. The north-western side is flattened as a consequence of it ceasing to grow and there was an old perennial fruiting body of the Southern bracket decay fungus (*Ganoderma australe*) at the base in the centre of this flattened section. This fungus causes a white-rot of the colonised wood due to the preferential initial selective destruction of the lignin. The wood is generally degraded relatively slowly by the fungus, retaining its tensile strength for a considerable period. During this time the tree typically responds by producing compensatory growth, as has happened in this case, the oak having developed large buttress roots to either side of the flattened area.

Photograph 2: Flattened north-western side of the base with the fungal fruiting body arrowed

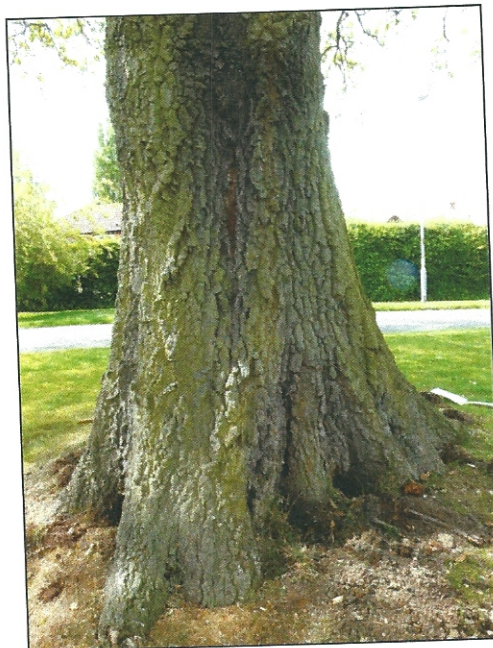
Photograph 3: Large buttress root on the southern side that has developed in response to the basal decay

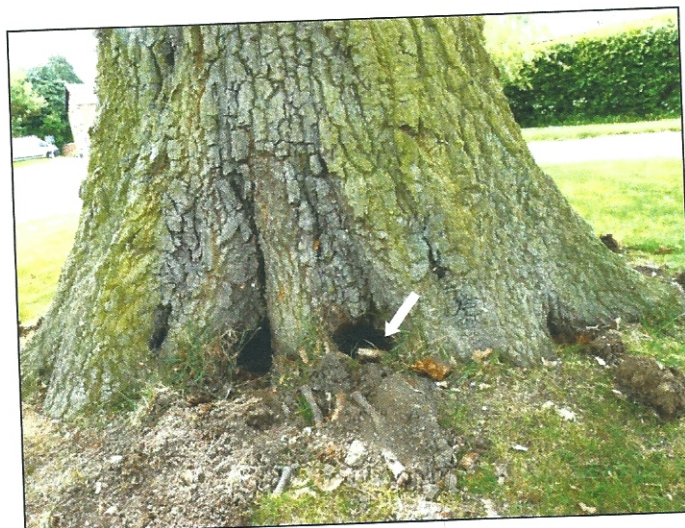
On the eastern side, there are two adjacent cavity openings, within which I found further old fruiting bodies of the Southern bracket fungus. The basal cavity extends under almost the entire radial cross section of the trunk and I was easily able to fully insert the 1.2 metre length of my steel shafted trenching spade into one of the openings.

Photograph 4: Basal cavities on the eastern side, with the handle of the fully inserted trenching spade arrowed

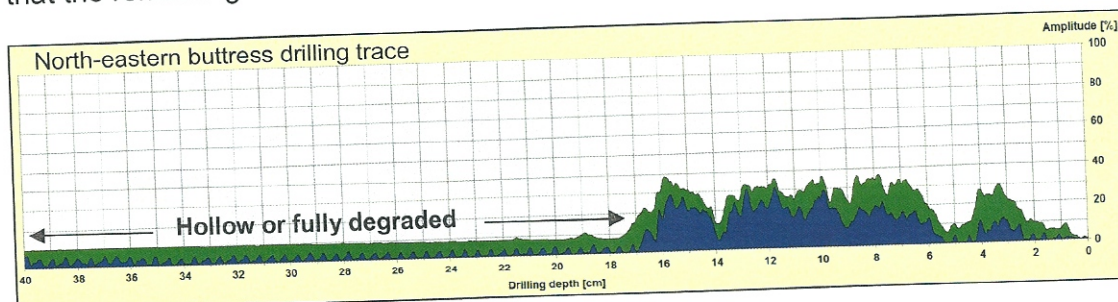
The drilling into the north-eastern buttress (on the left side in photograph 2) indicated that this is fully degraded or hollow beyond a depth of 17cms, where the drill curve falls and flattens. However, the erratic nature of the traces up to this point indicates that the remaining outer shell of wood is already partially degraded.

The extent of the decay and associated hollowing renders the tree susceptible to collapse either as a consequence of the failure of the buttress roots or the cross sectional flattening of the hollow trunk. Given the proximity of the oak to the road, and the potential consequences if it were to fail, a more cautious approach needs to be adopted than if it were growing in a more isolated situation. Regrettably, I find myself with no option but to recommend that the tree be removed and an appropriate replacement planted in a suitable location nearby.

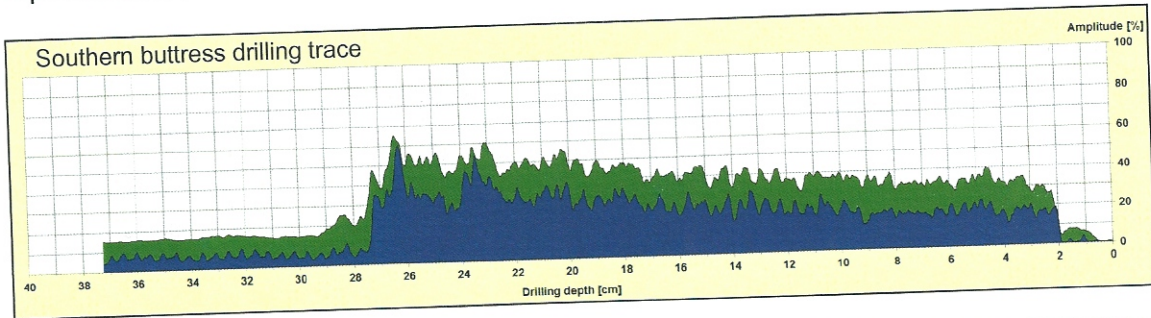
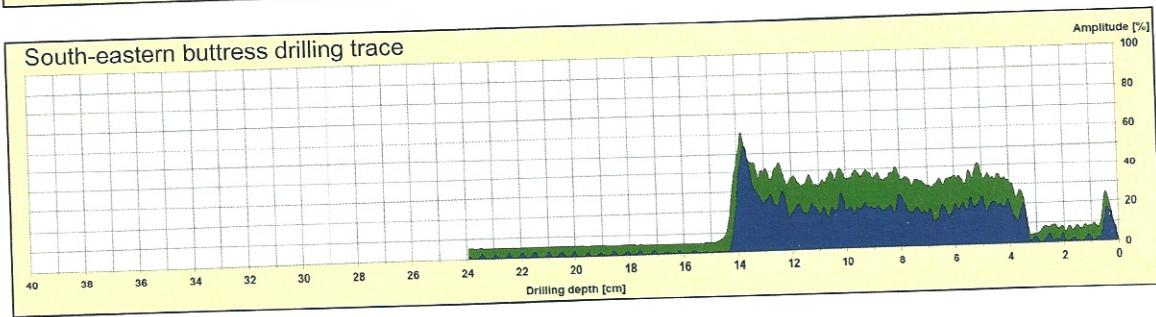
The drilling into the large southern buttress indicated that this is fully degraded or hollow beyond a depth of 27cms and in the case of the south-eastern buttress, the drilling indicated that the wood is fully degraded beyond a depth of 13.5cms. Only the western buttress appeared to retain a reasonable depth of wood unaffected by the decay. The traces of the drillings into the southern and south-eastern buttresses are reproduced below.

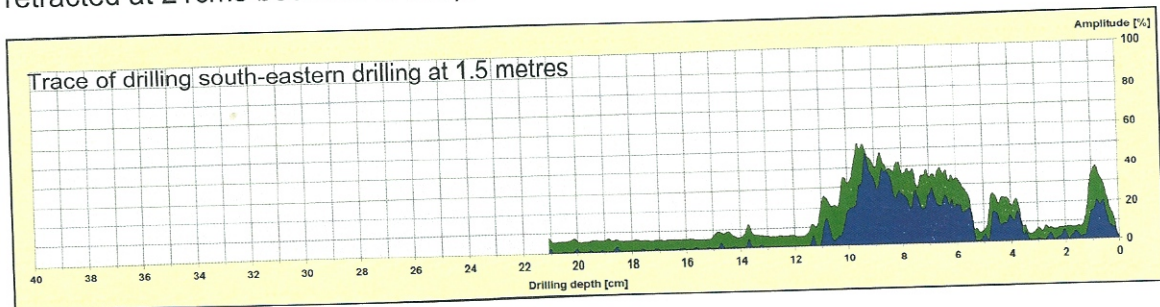
Further drillings into the north-western, south-western and south-eastern sides at a height of 1.5 metres showed that the decay extends up the trunk at least to this level and that the residual shell of apparently structural viable wood at this level ranges from just 10 to 13cms, which equates to an average of around 18% of the radial cross section. The trace of the drilling into south-eastern side, reproduced below, shows the trunk is hollow beyond a depth of 11cms (the needle automatically retracted at 21cms because of this).
