Picus Tomography and Arboricultural Report

The Green, Main Rd/chapel Lane, Old Dalby, LE14 3LR

Project no. J190637

Tree Ref - T1 - Turkey Oak

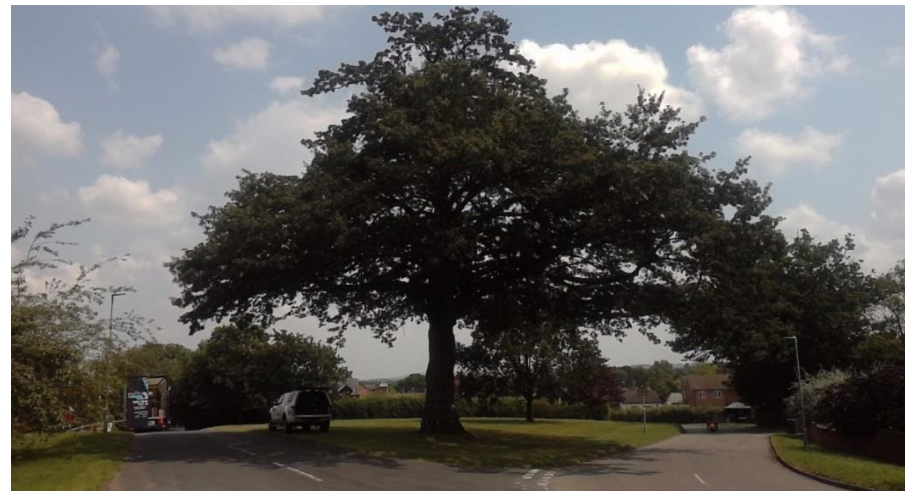
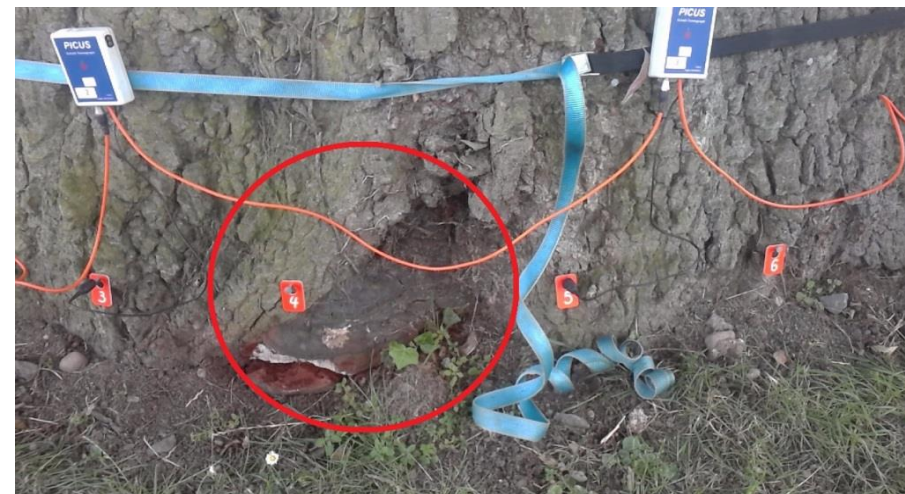
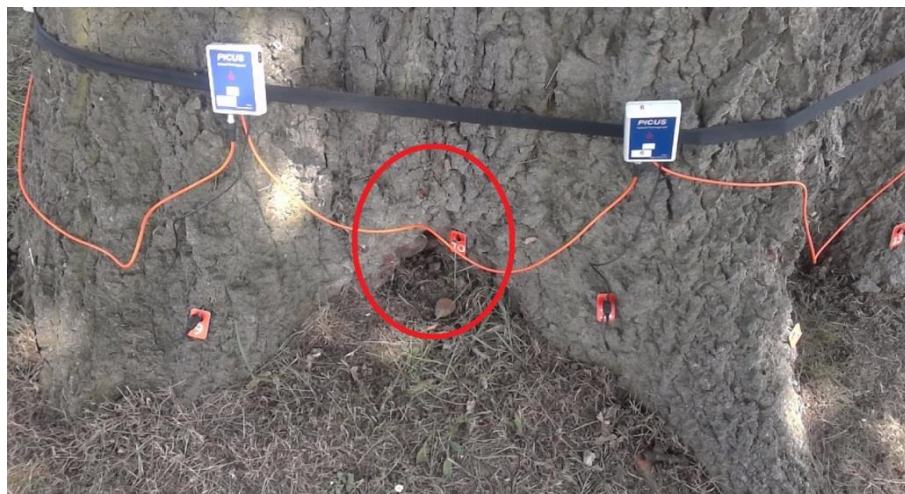
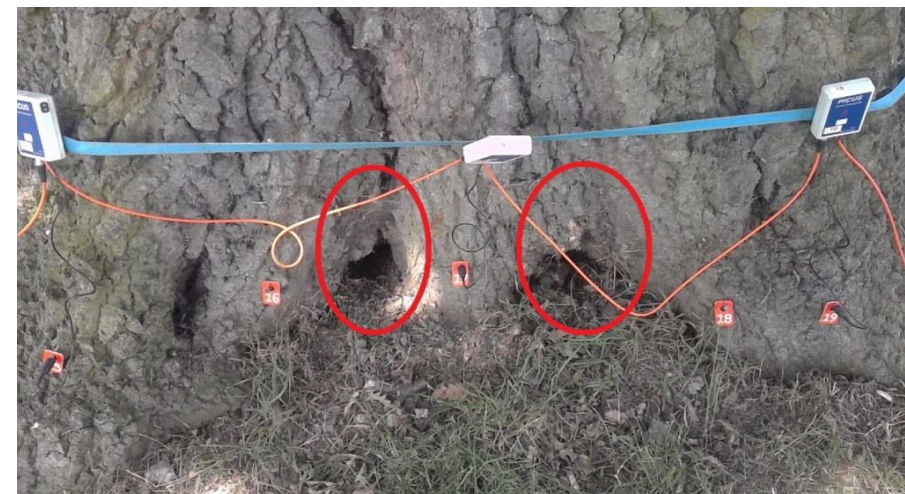
5.30 Photos

Mature Ganoderma australe bracket at base on western side. Open cavities x2 on eastern side and x1 to the south at base between buttressing. Cavities are at least 1m deep into centre of trunk. Sound buttressing to the north, south east, south and south west. No buttressing on western side where ganoderma is situated. Sound testing with hammer reveals hollow sounding predominantly on western side up to 1.5m. Further hollowing on eastern and southern sides.

8.10 Option 1: Monolith at 7m, leaving lowest structural branches at approx 1.5m from trunk on southern side and shape remainder. This will considerably foreshorten tree to target and all but eliminate any wind sail. Considering the current crown vitality of the tree, it will soon develop significant epicormic growth which it is hoped will retain a "vestige" of a much loved tree. Future management will require cyclic pruning of any re-growth and it is recommended that a pull test is carried out periodically to confirm stability.

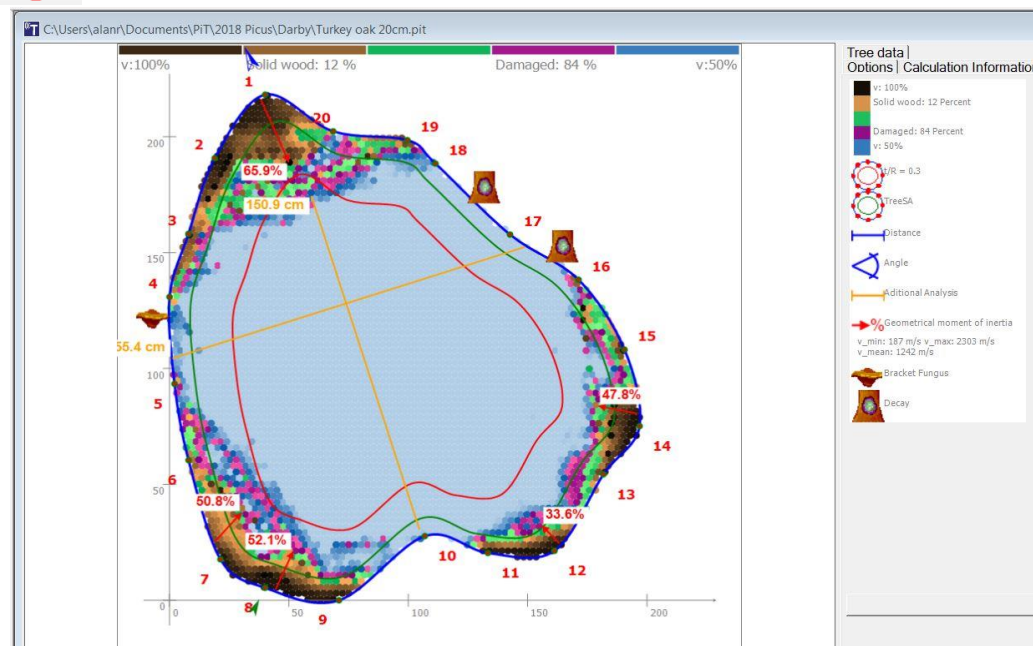
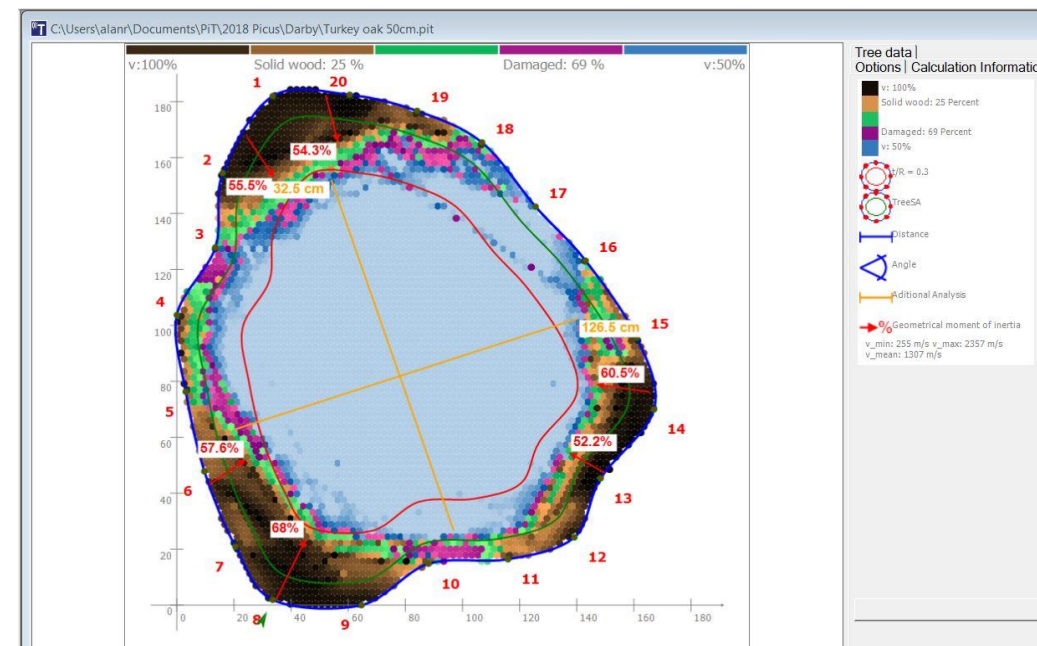
5.4.2 20 cm Test

5.3.2 50 cm Test

The superimposed red line indicates the 1/3 radius safety margin. t/R ratio

The maximum size of a possible cavity that coincides with the remaining stability calculated is shown by a green line.

5.5.1 The Picus tomograph images show an area of hollowing throughout the main stem which although gradually decreases in size, also extends up into the trunk to at least 200cm above ground level. Maximum amount of damaged wood is 84%. Although the tree has tried to compensate with large buttress roots the area around the ganoderma is a flattened section with no compensatory growth. Ganoderma austale causes a white rot by selective delignification especially within the rays leaving a white spongy fibrous mass. This can cause radial cracking, cross sectional flattening of the hollow trunk or failure of buttress roots.

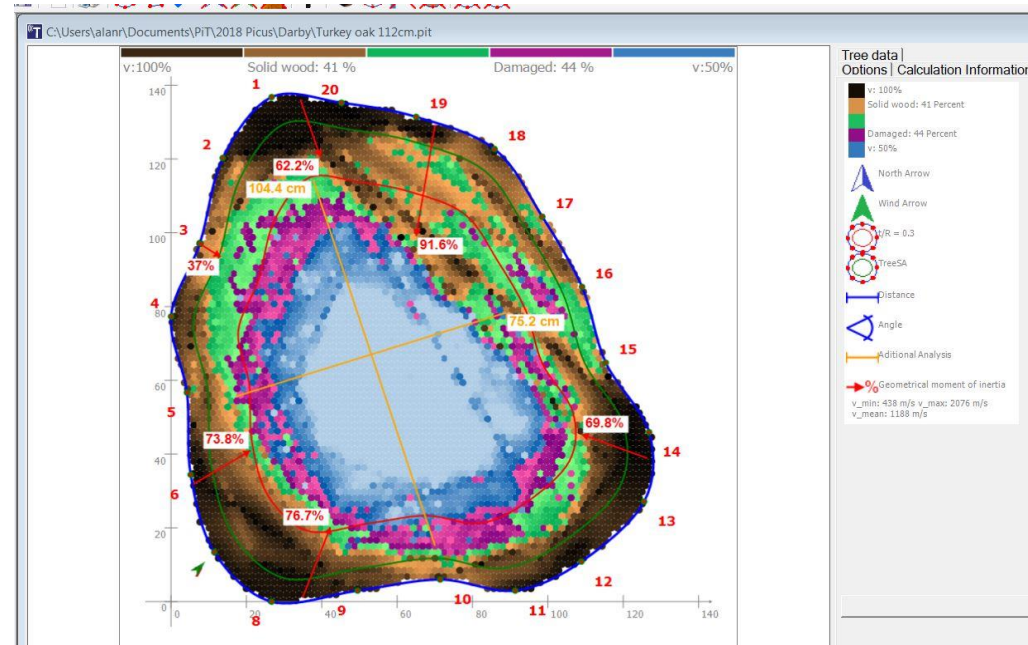
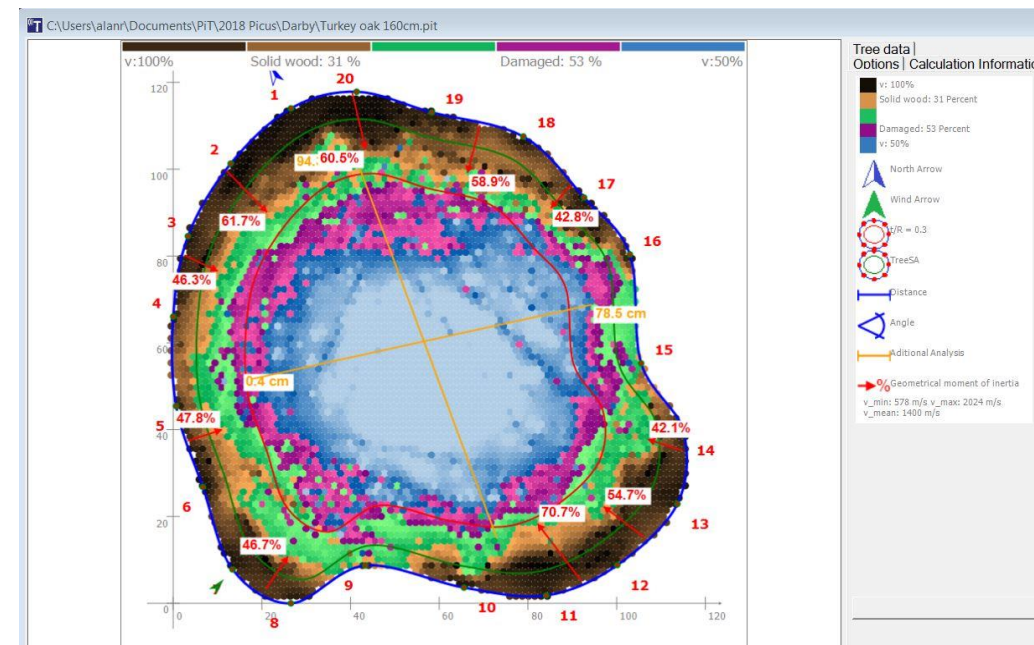
5.4.3 112 cm Test

160 cm Test

The superimposed red line indicates the 1/3 radius safety margin. t/R ratio

The maximum size of a possible cavity that coincides with the remaining stability calculated is shown by a green line.

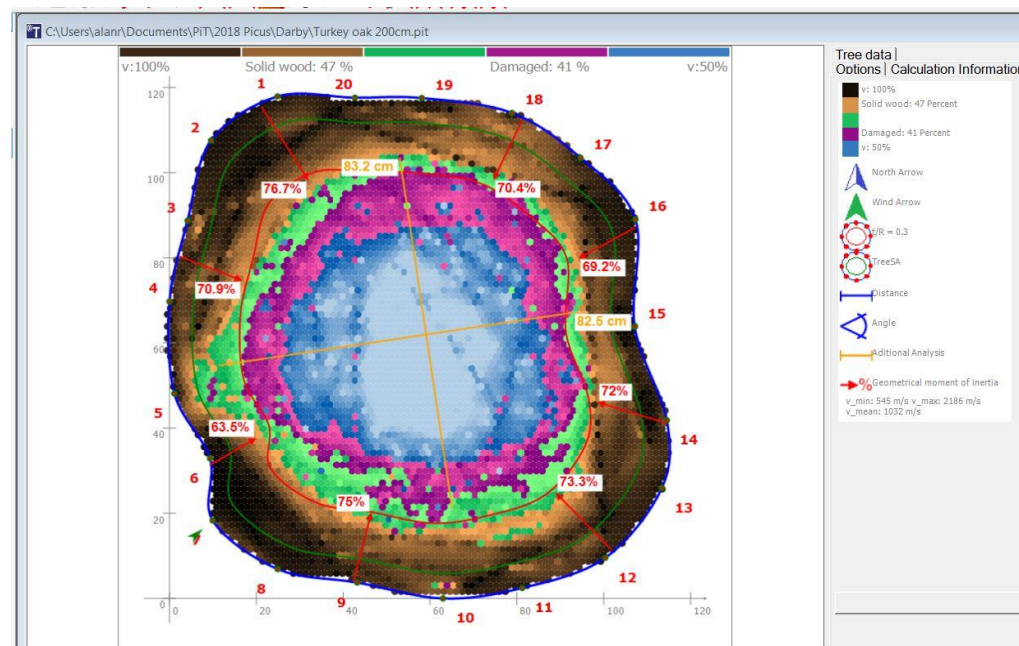
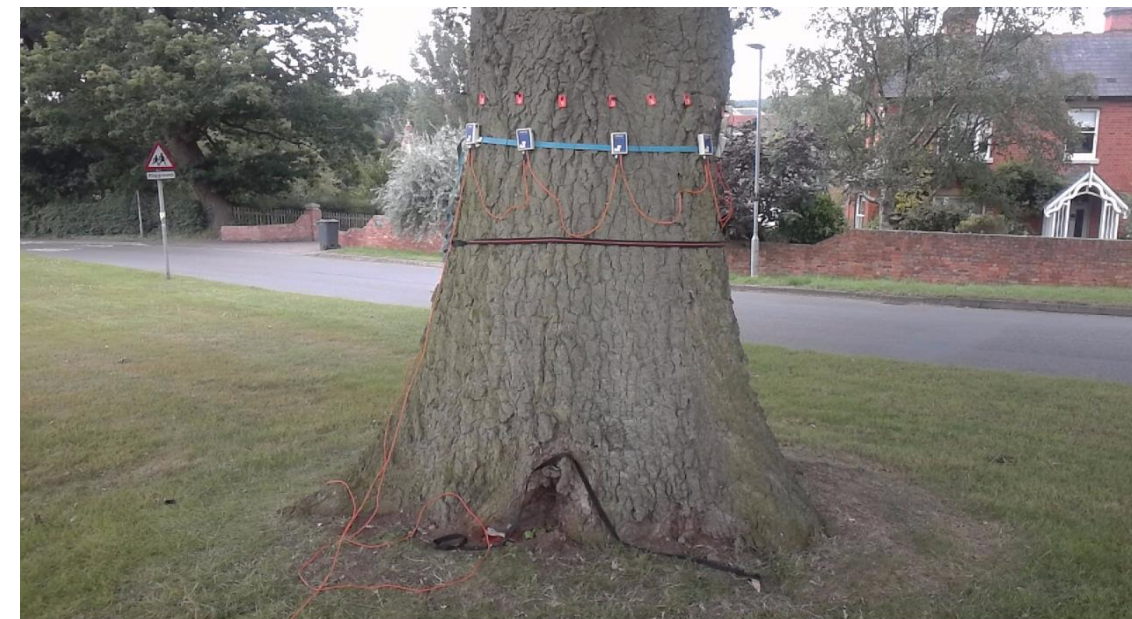
5.4.3 200 cm Test

The superimposed red line indicates the 1/3 radius safety margin. t/R ratio

The maximum size of a possible cavity that coincides with the remaining stability calculated is shown by a green line.
